Recovering from the GNIRS Overheating

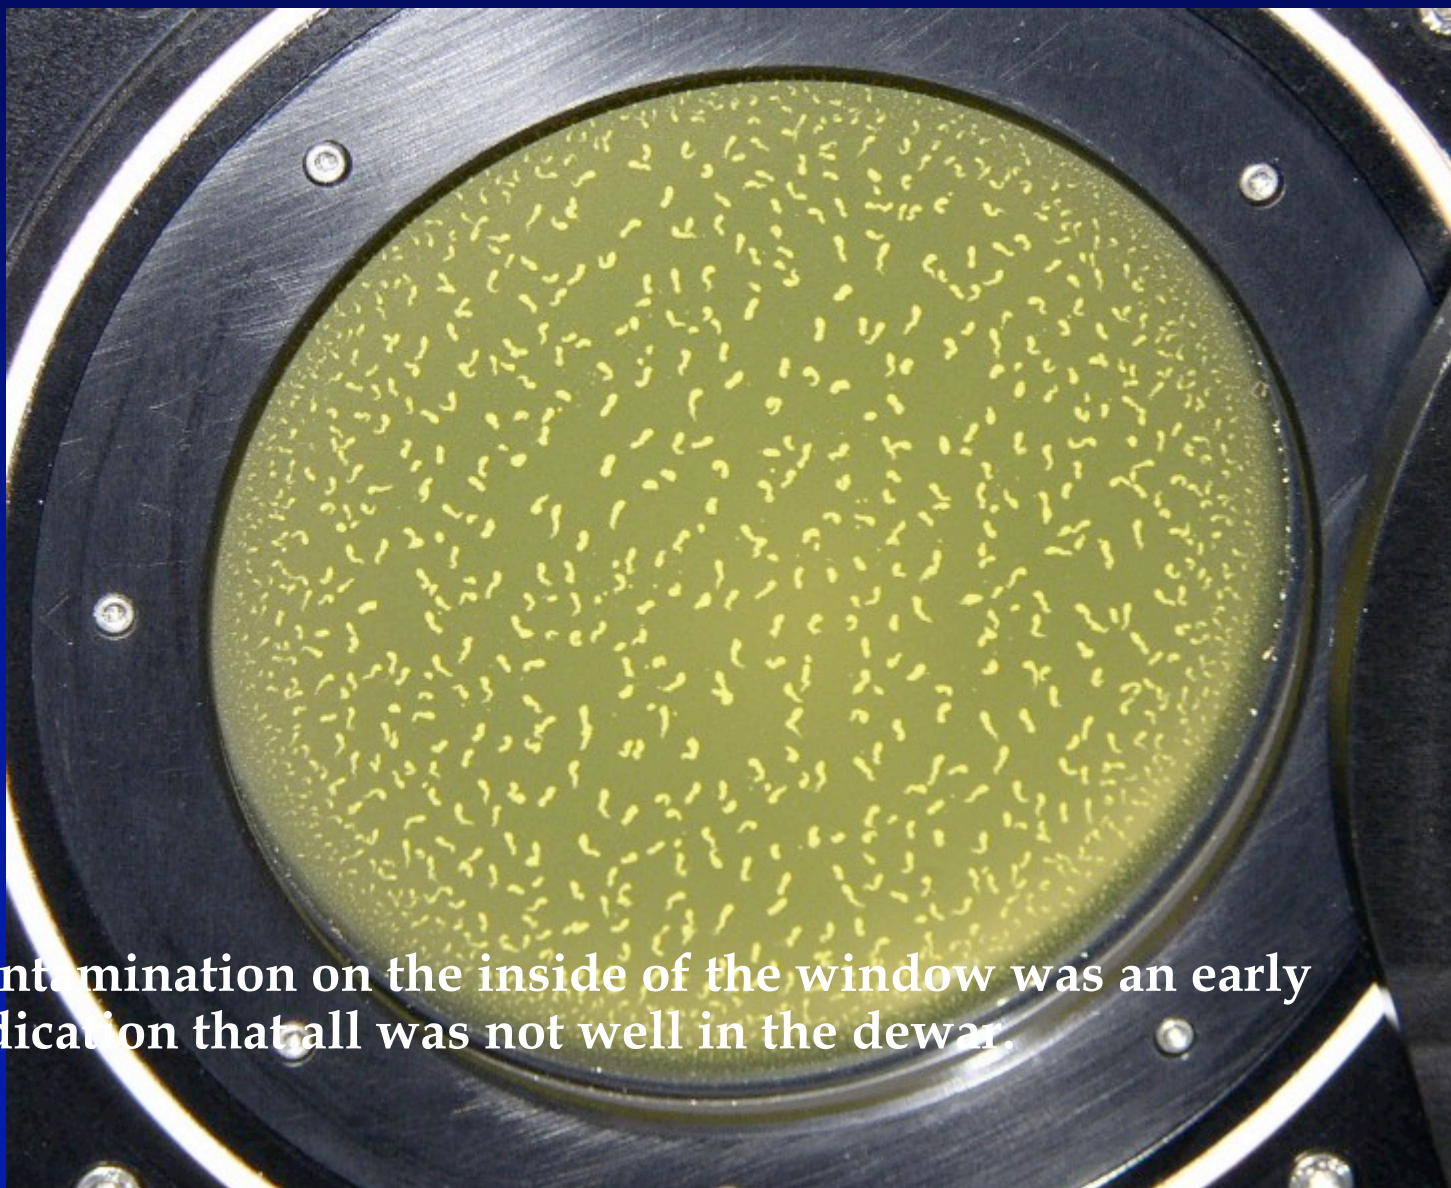
Contamination on the inside of the window was an early indication that all was not well in the dewar.

After the initial inspection, it was obvious that some components were damaged, but many are clearly fine. Interestingly, vaporized plastic and resin condensed on the window, the outer vacuum jacket and radiation shields, which were the coolest parts (near ambient temperatures). Much of the interior was relatively clean.

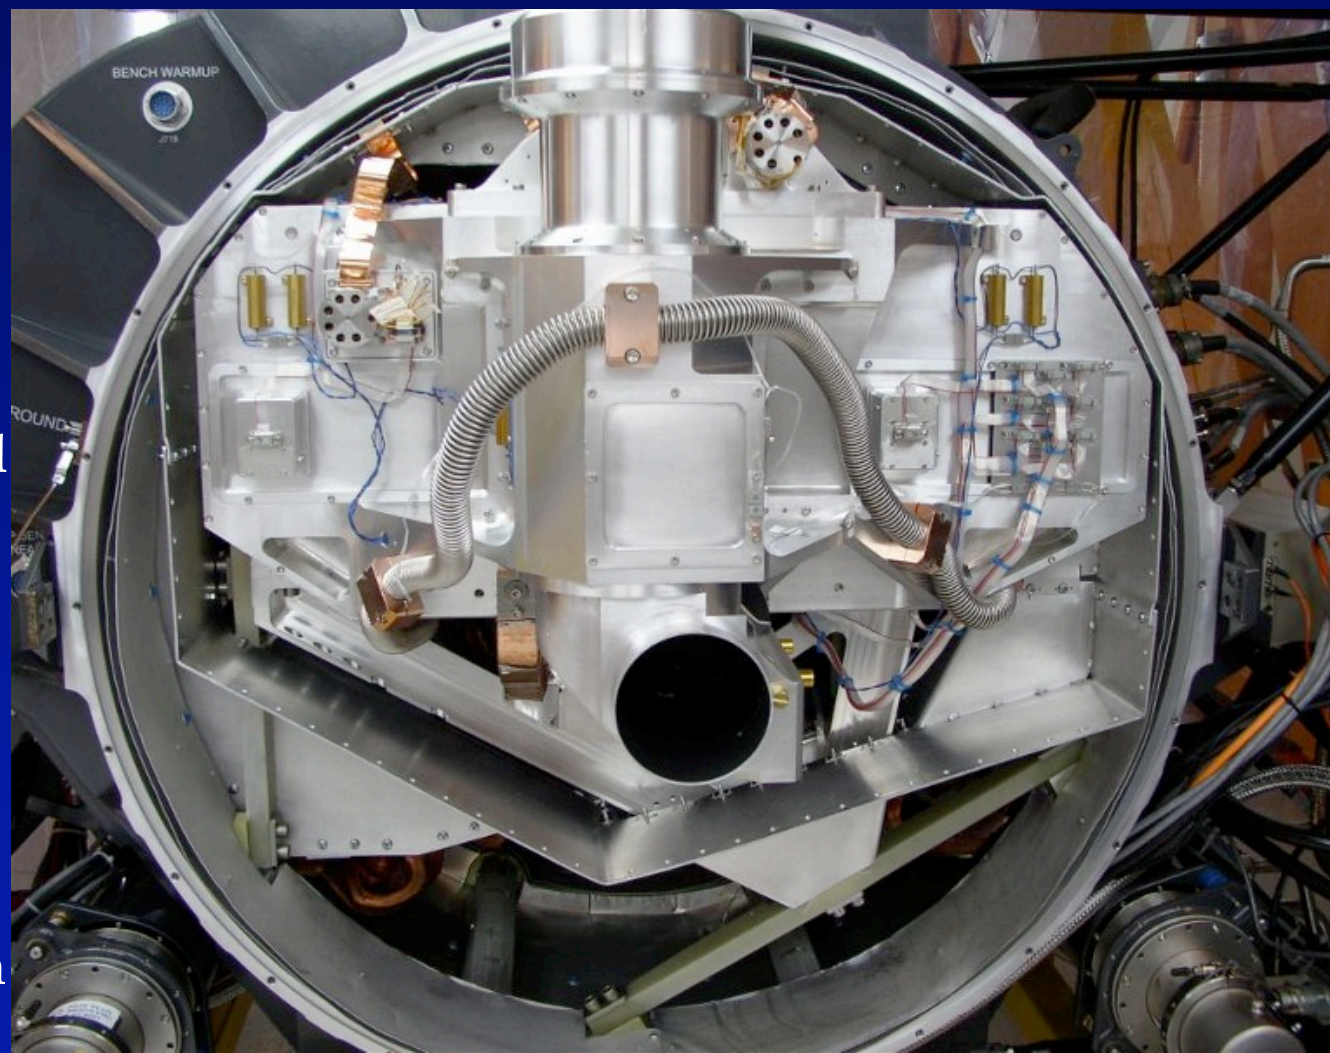
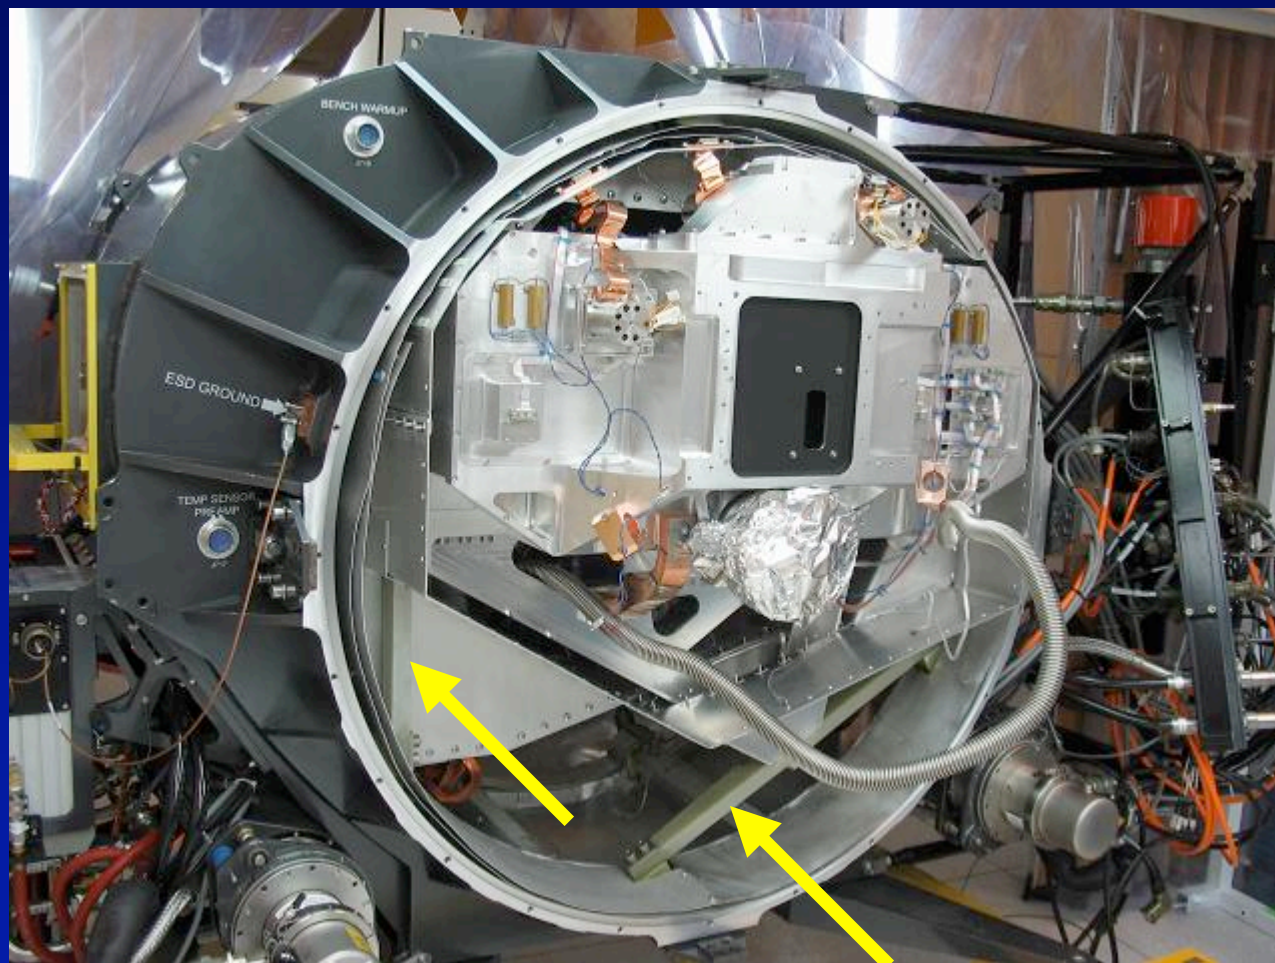
GNIRS suffered some structural damage to the G10 fiberglass struts that support the full weight of the optical bench.

The fiberglass resin did not survive the baking and some of the struts cracked or broke.

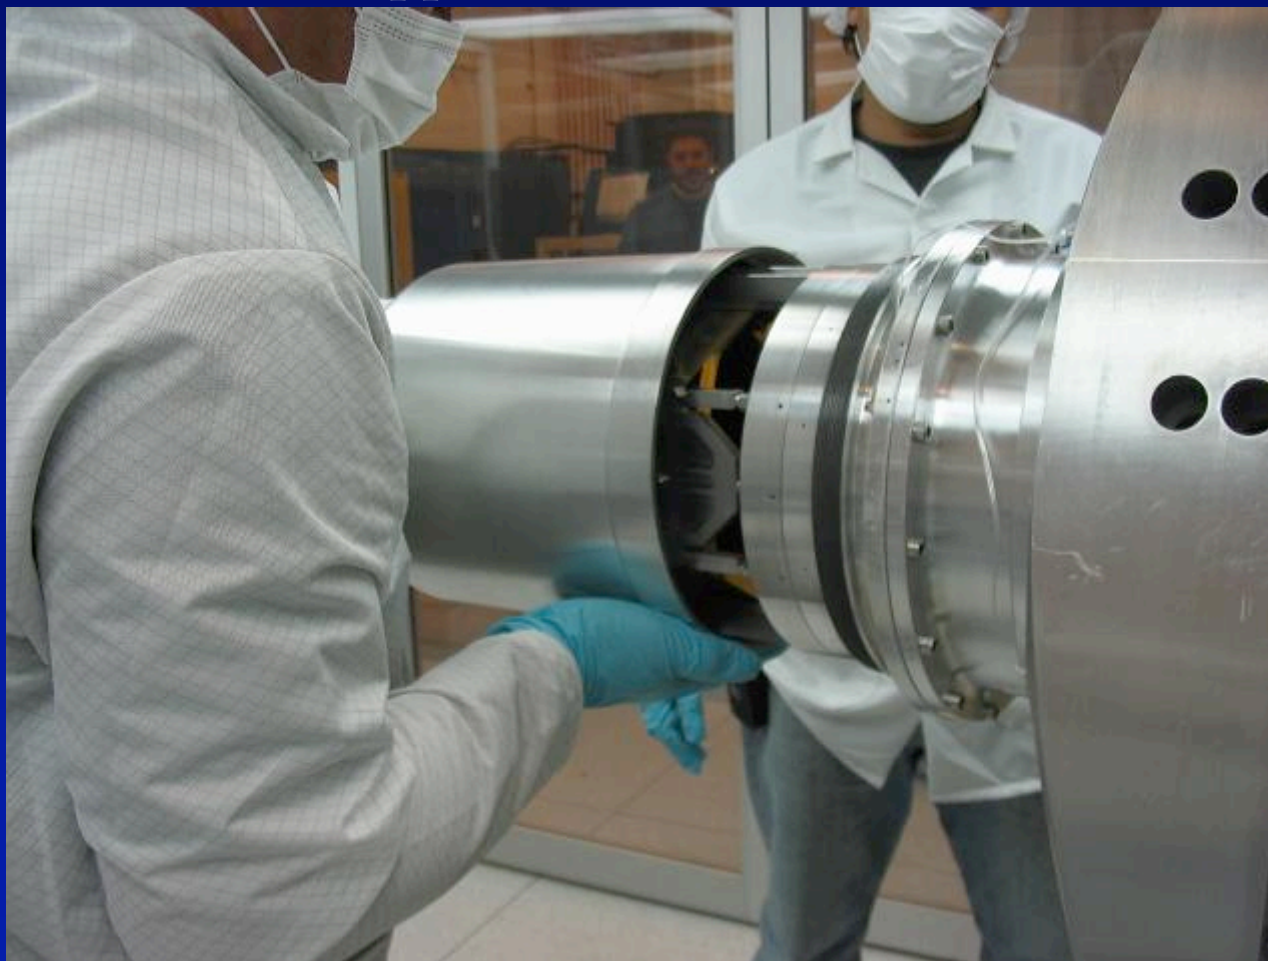
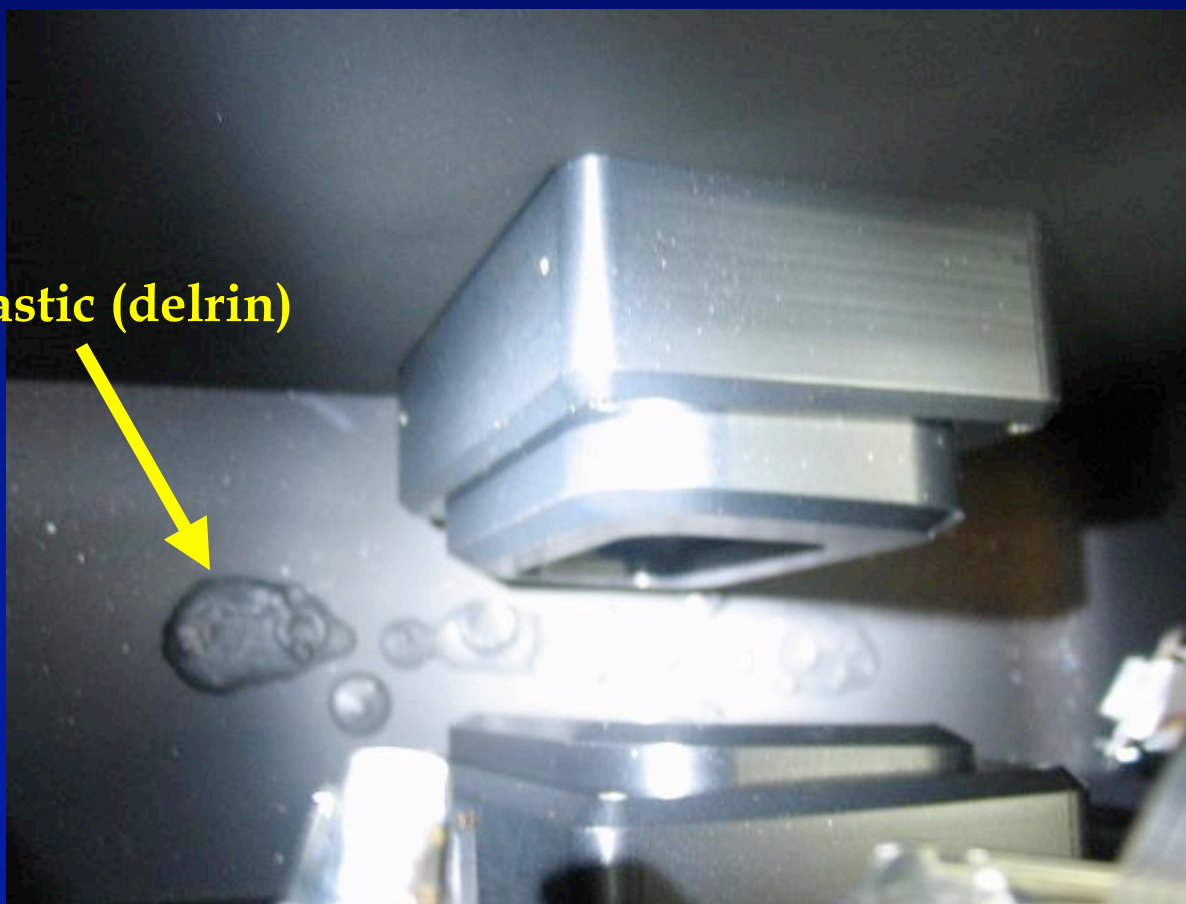
Everything with a low melting point melted.

Melted plastic (delrin)

In particular, the delrin plastic spacers used in filter wheels and lens assemblies melted, and will need to be replaced.

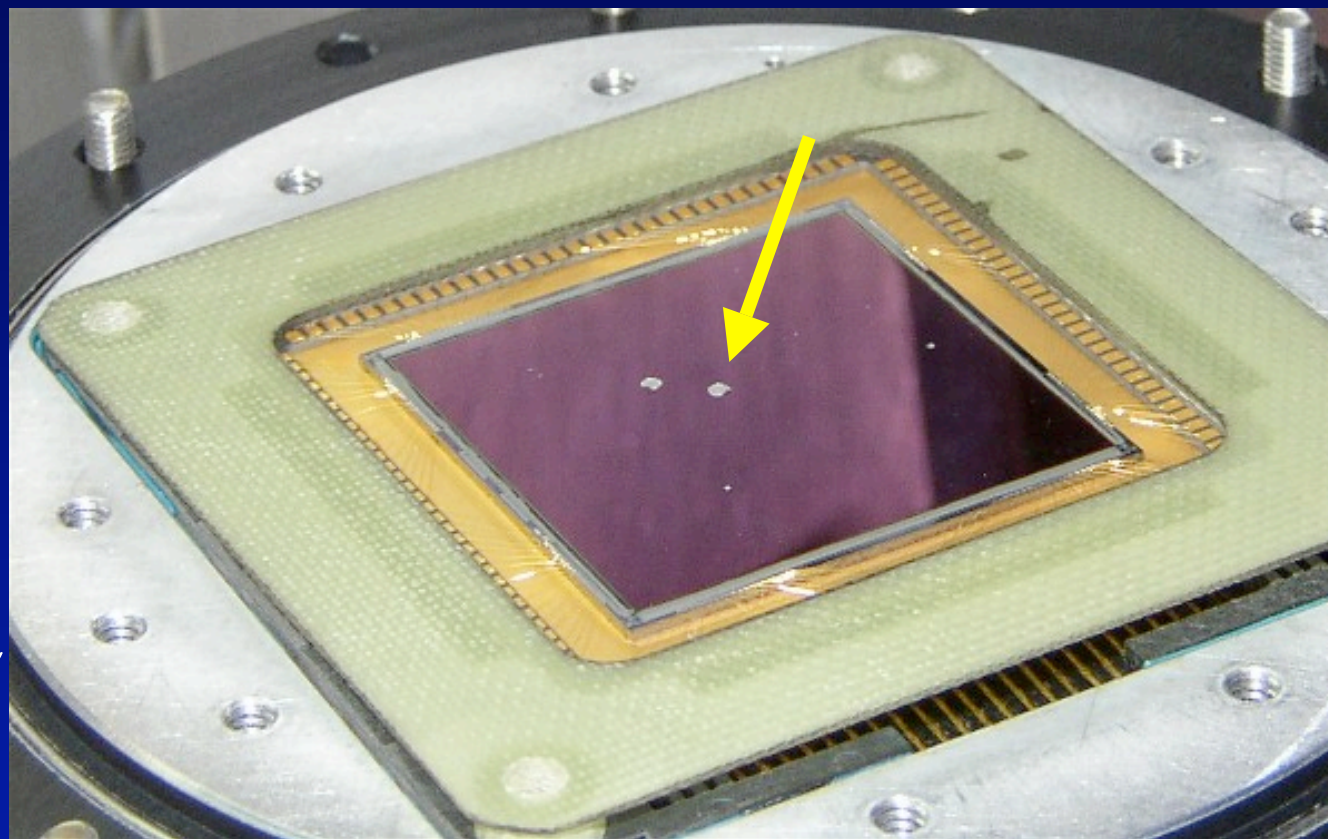
Unfortunately, the science detector was lost. Note the holes in the InSb Aladdin 3 detector – a close inspection shows the bump bonds and MUX underneath. Indium has a low melting point (120°C), and the array was damaged beyond repair.

Indium is used to bump-bond the InSb detector to the underlying Si multiplexer. It is also used as an electrical insulator connecting the cold strap to the detector mount.

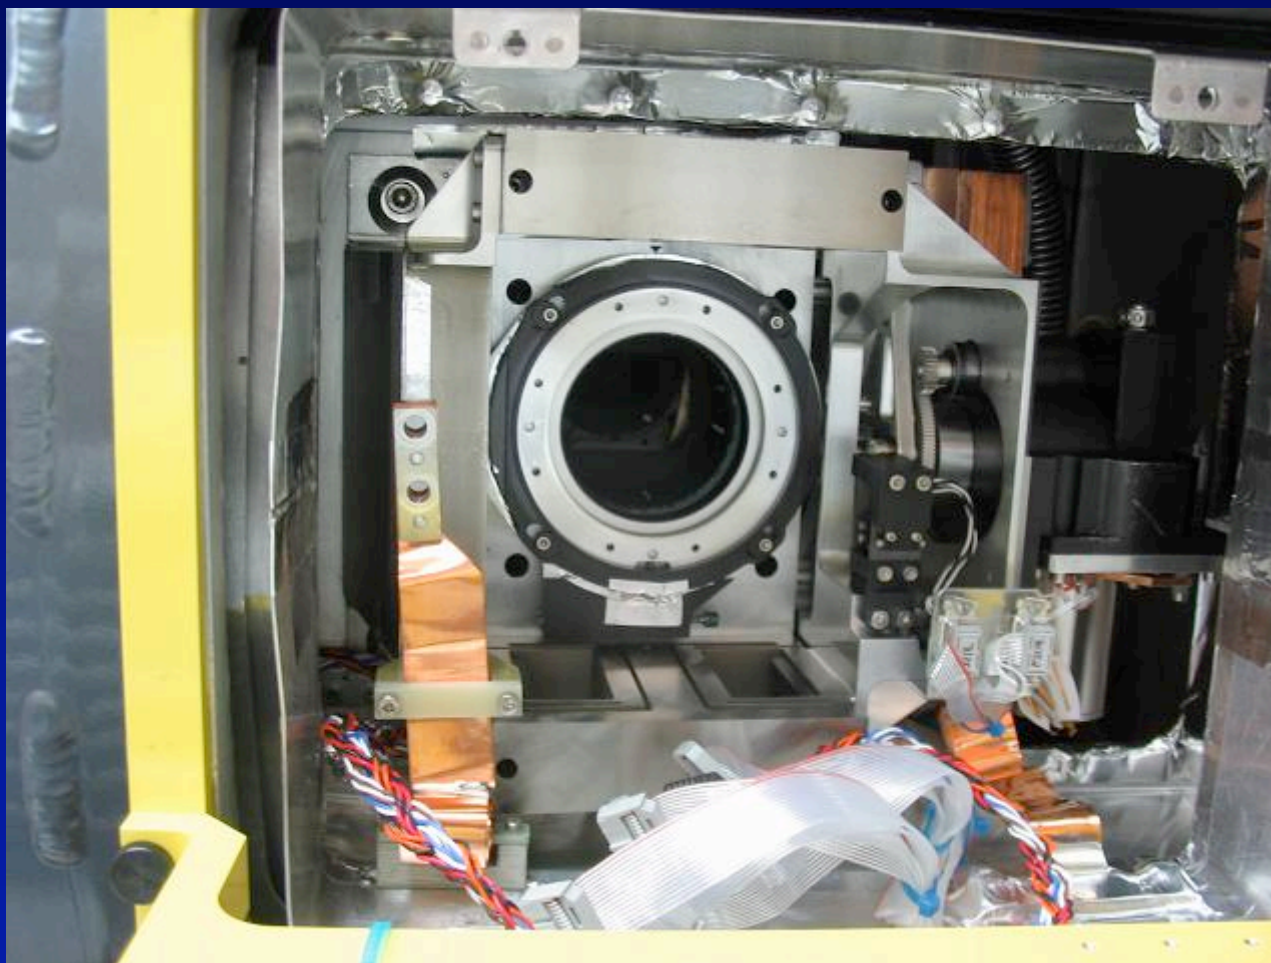
The wiring, connectors, and insulation all appear to have survived.
