by Joseph Jensen & Scot Kleinman

GNIRS Update

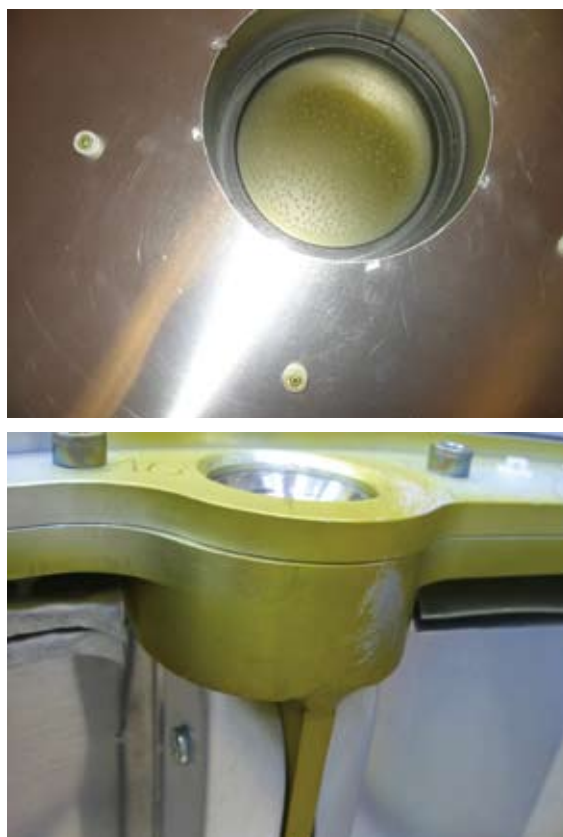
Figure 1.
Top image: the contaminated entrance window from inside the dewar. The screw heads and inner baffle also show signs of the discolored contamination seen more clearly in the bottom image of the GNIRS interior. Small areas of the contamination have been cleaned off for illustration.

We are now working to fix or replace the damaged parts. The G₁₀ fiberglass supports have already been replaced. The resin in the original supports broke down, and a yellowish deposit is now coating parts of the vacuum jacket (the coldest part of the instrument during the overheating event). The fiberglass was structurally compromised, and the replacements had to be installed before GNIRS could be shipped to Hilo for further repairs.

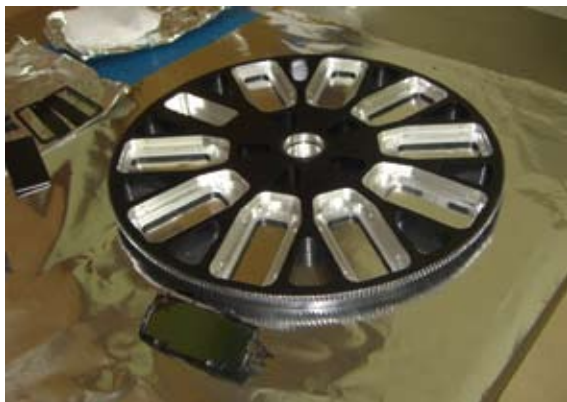
Figure 4.
The restored filter wheel and a sample damaged filter from GNIRS.

The installed science filters were damaged beyond repair, but will be replaced with existing spares and new procurements as necessary.
