Recovering from the GNIRS Overheating

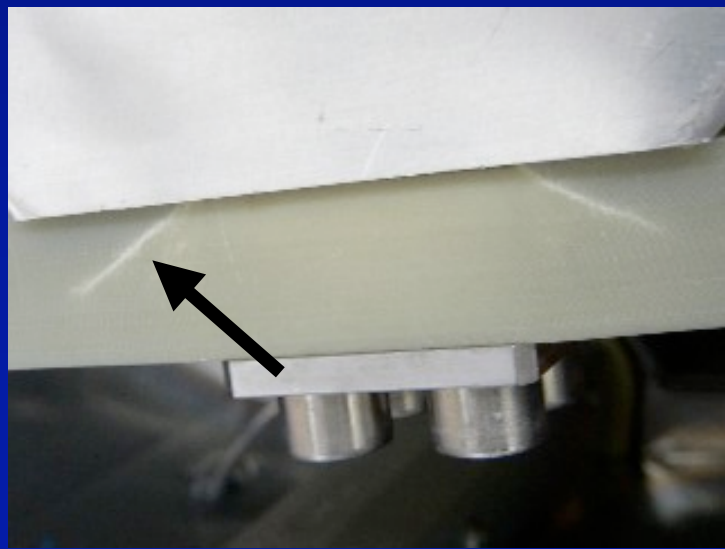
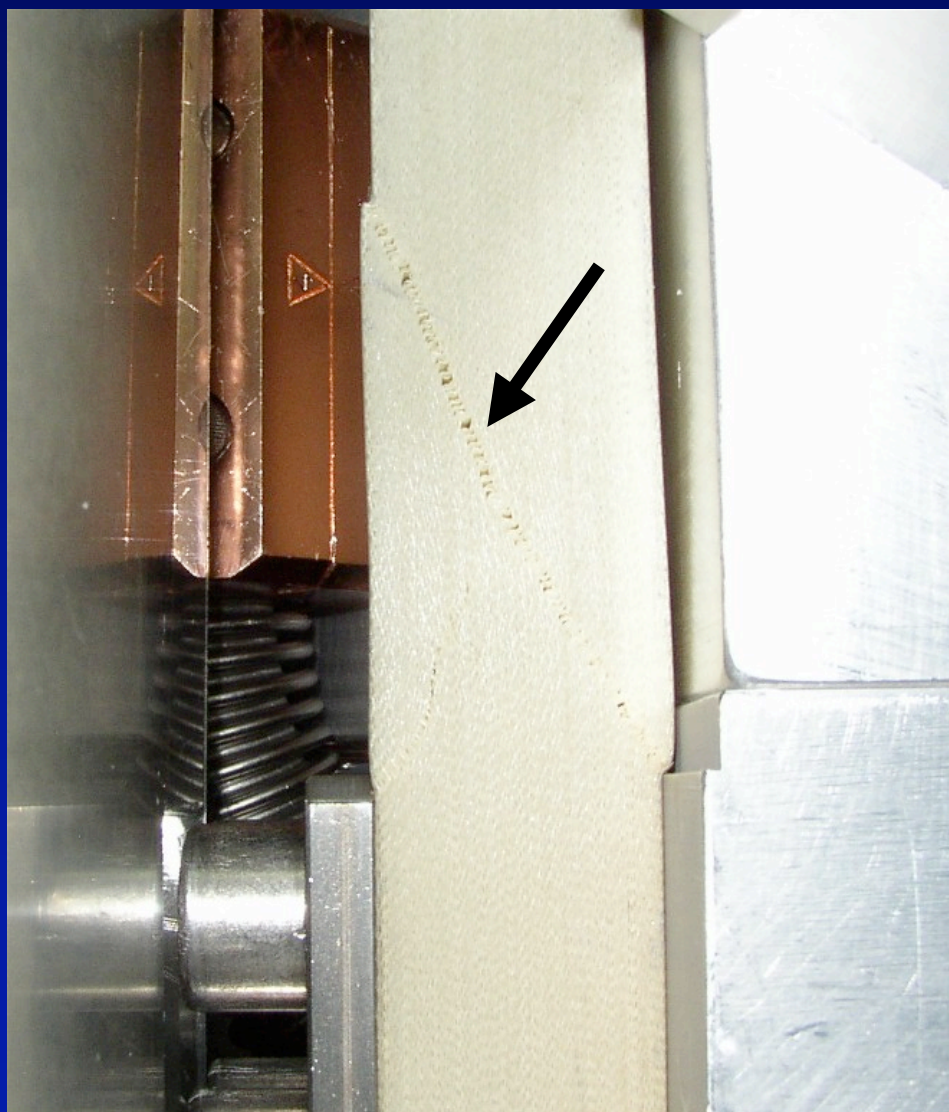
GNIRS suffered some structural damage to the G10 fiberglass struts that support the full weight of the optical bench.

The fiberglass resin did not survive the baking and some of the struts cracked or broke.
